Manhole Inspection Summary

Manhole # S27C1_014MH

Insp Date: **4/16/08 2:38 PM**

Location Address: **BEHIND 2357 SIDNEY AV.**

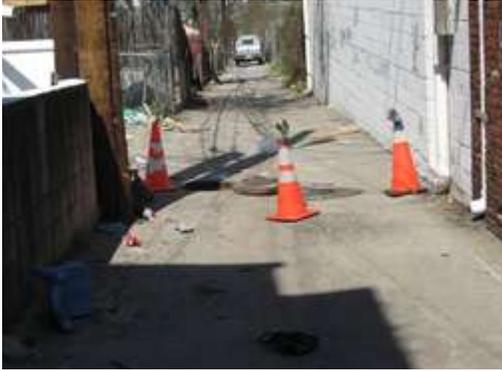
Location View

Comments **MH APPEARS TO BE ABANDONED - CANT GIVE ACCURATE 12 O CLOCK MEASUREMENT BECAUSE OF DBRIS IN CHANNEL. APPROXIMATE FIGURE ONLY.**
